Re: As Built monitoring report for Haley's Ditch Restoration Project
USACE Application number 2008-01179

Haley's Run Restoration Report

**Lockheed Martin
Haley's Run Restoration Report**

The following information is the third year monitoring report for the restoration of Haley's Run, required by the USACE Nationwide 38 permit for the remediation and restoration of Haley's Run (permit number 2008-01179). EnviroScience Inc. and the RiverWorks Team completed the stream and wetland restoration of Haley's Ditch on June 30, 2010. The restoration of Haley's Run centered on enhancing the remediation area within the limits of contaminated sediment removal. Lockheed Martin made the conscious decision to spend additional resources to provide a functional stream valley, floodplain and riparian corridor as a foundation for ecological recovery. Therefore, the limits of remediation became the limits of restoration. The restoration also focused on repairing existing impairments and limitations of channel morphology, habitat and riparian zone that occurred historically to Haley's Ditch. For additional information on Haley's Run regarding existing conditions prior to remediation and restoration a

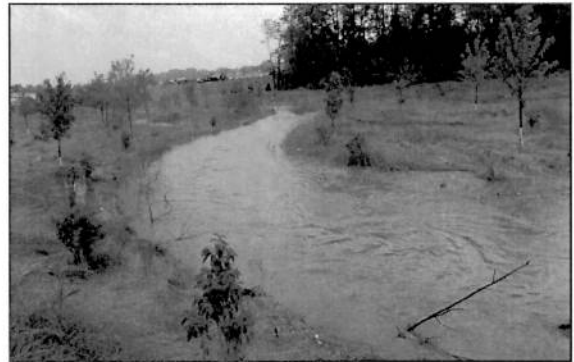
Figure 1. Haley's Flood Stage

To date, the restored stream is functioning very well. There have been significant precipitation events in 2012 and in 2011, and the channel and banks have demonstrated exceptional stability throughout different stages of channel maturity (i.e., vegetation growth). The erosion fabric and grass seed mix has performed well and minimized erosion. However, some erosion has occurred near the second pool downstream of the beginning of the project area in 2011. When this was first observed, willow live stakes were planted along the outside meander, as well as installation of layers of branches. This was done to help decrease sheer stress on the bank and reduce future erosion. The live stakes and branch layering techniques worked in that immediate area, but erosion has continued on the downstream side of the protection. Besides that, deposition has occurred along inside meander bends, maintaining point bars, and pools have maintained their depths. More importantly, floodwaters are able to access the floodplain which is evident by Figure 1.

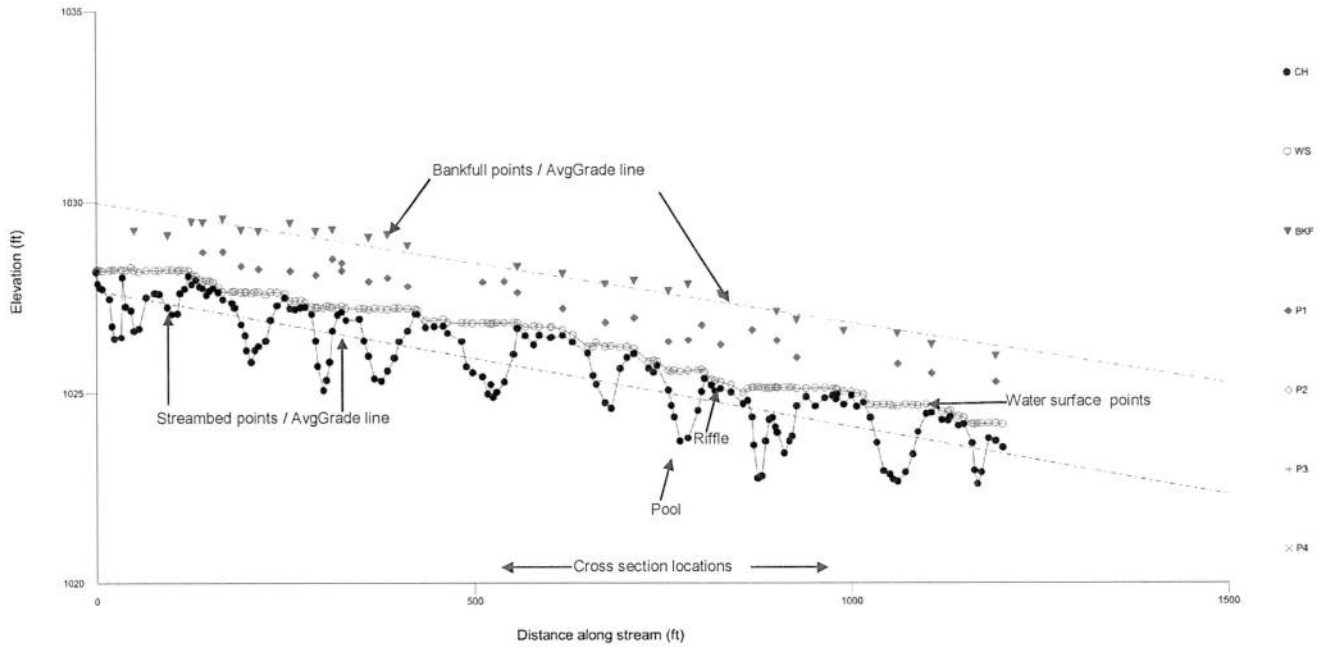
Figure 7. Haley's Run Longitudinal Profile Station 0+00-12+00

The stream bed profile was constructed as per plan with only minor horizontal shifts in the start or end of a feature. No riffles/pools were eliminated or significantly altered from the design plan. The profile also indicates that the average bankfull slope 0.0033ft was achieved with bank construction and floodplain grading. Some profile adjustment was observed at the most upstream reach of the project area. This adjustment was limited to deposition in the pool immediately downstream of the Triplett Rd culvert, and did not adversely affect the project area downstream.

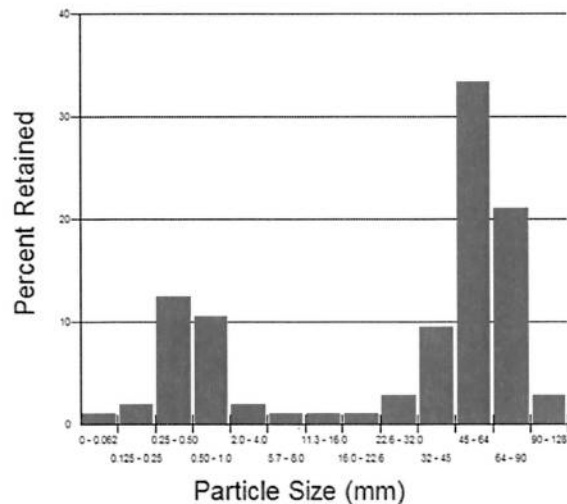
Figure 10. Cobble/Gravel Distribution

The results (Figure 10) indicate a distinct cohort of gravel/cobble material and sand component in the installed top layer of the substrate. The gap in the distribution relates to fine gravel (2.0-4.0 mm) and medium gravel (14.0-26.0 mm) that is anticipated to arrive from sediment transport upstream*. This is based on observations of the existing channel and of newly deposited material below the Triplett Rd culvert. The installed top layer of cobble/gravel material was intentionally biased towards larger particle sizes that would not be delivered from upstream bedload.

***2012 Update:** During the 2012 monitoring survey, the dominant substrate types observed were cobble, and both medium and fine gravel. As expected, sediment from upstream is being transported through the stream, contributing to more balanced substrate heterogeneity. No net aggradation or degradation was observed.

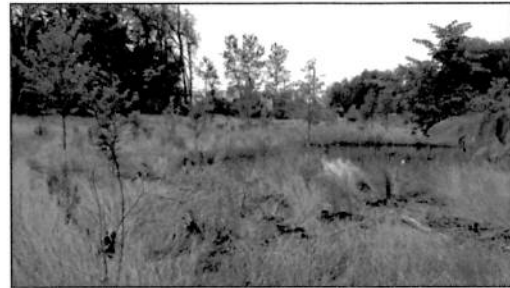
Figure 11. Flood Debris at inlet

Wetland 1- Is a 0.045-ac riverine wetland constructed along the original alignment of Haley's Ditch. Floodwaters access this wetland on a regular basis evident by flood debris (Figure 11). Furthermore, the wetland has a groundwater source that maintains a fairly constant water level throughout the majority of the year (Figure 12). Because of this, the wetland community associated with this area will be slightly different from the seasonally inundated wetlands that have a more fluctuating hydrologic regime. Overall, this is a positive outcome and adds more diversity to the type of wetland habitat restored with the project.

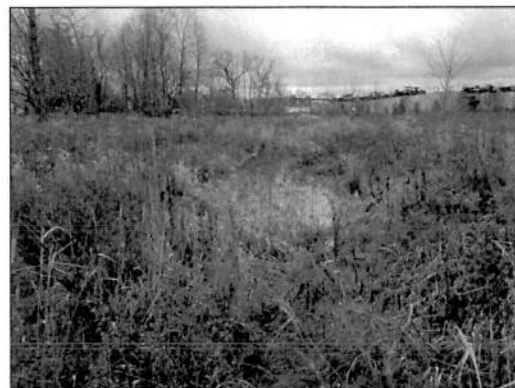
Figure 13. Wetland 2

Wetland 2- Is a 0.012-ac riverine oxbow wetland constructed in the South zone also on the previous Haley's ditch alignment (Figure 13). However, this wetland does not have the groundwater input seen in Wetland 1, and has a more fluctuating hydrologic regime.

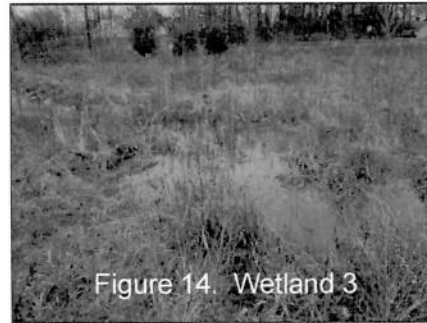
Figure 14. Wetland 3

Wetland 3 is a riverine 0.017-ac oxbow wetland constructed within the south zone western expansion area. This wetland receives surface water runoff from the LKQ facility. A small intermittent stream with a series of step-pools was constructed at a grade of approximately 10% to convey water from the upper slope to the wetland area. The outlet of

this wetland is another small intermittent stream approximately 80ft in length that confluences with the main channel at the end of the South zone (~Station 16+50).

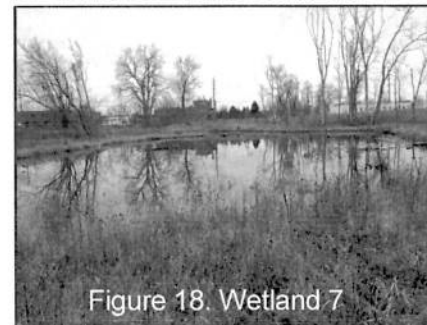
Figure 18. Wetland 7

Wetland 7 is a 0.90-ac riverine wetland that occupies the majority of the western portion of the restoration project in the North zone. This wetland has multiple inlets where floodwaters can access the area. Observations throughout the year suggest that approximately 0.5 inches of rainfall begins to supply water from Haley's Run. A large part of this wetland has remained inundated throughout the year. The average depth in the wetland is approximately 1 ft with a maximum depth just over 2 ft.
