Re: As Built monitoring report for Haley's Ditch Restoration Project
USACE Application number 2008-01179

Haley's Run Restoration Report

**Lockheed Martin
Haley's Run Restoration Report**

The following information is the third year monitoring report for the restoration of Haley's Run, required by the USACE Nationwide 38 permit for the remediation and restoration of Haley's Run (permit number 2008-01179). EnviroScience Inc. and the RiverWorks Team completed the stream and wetland restoration of Haley's Ditch on June 30, 2010. The restoration of Haley's Run centered on enhancing the remediation area within the limits of contaminated sediment removal. Lockheed Martin made the conscious decision to spend additional resources to provide a functional stream valley, floodplain and riparian corridor as a foundation for ecological recovery. Therefore, the limits of remediation became the limits of restoration. The restoration also focused on repairing existing impairments and limitations of channel morphology, habitat and riparian zone that occurred historically to Haley's Ditch. For additional information on Haley's Run regarding existing conditions prior to remediation and restoration a

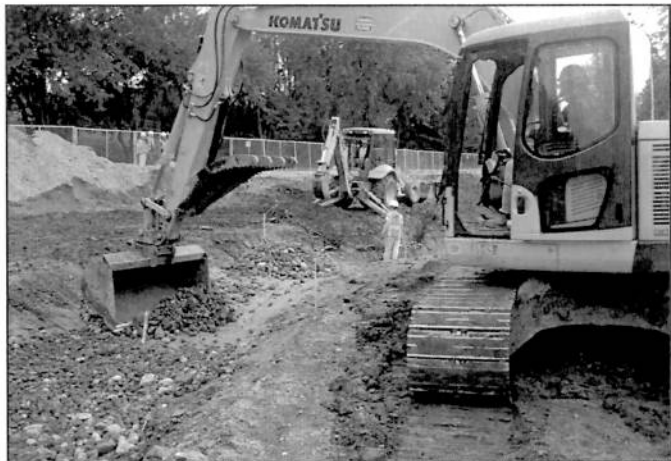
Figure 9. Substrate Installation

Cobble/gravel material was shaped and compacted in place with an excavator bucket (Figure 9). The particle distribution sampled on 10/16/09 (Table 2) shows the gradation of cobble/gravel material that was typically installed to finish grade. This distribution is based on a 105 particle sample.

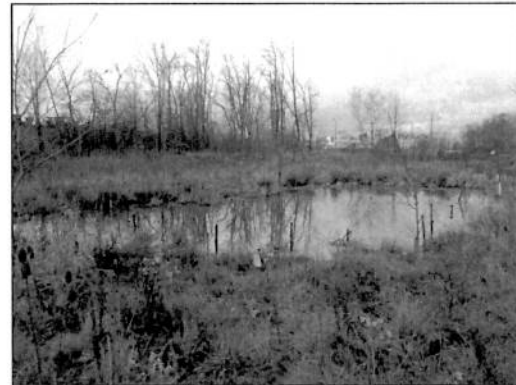
Figure 12. Wetland 1

Wetland 1- Is a 0.045-ac riverine wetland constructed along the original alignment of Haley's Ditch. Floodwaters access this wetland on a regular basis evident by flood debris (Figure 11). Furthermore, the wetland has a groundwater source that maintains a fairly constant water level throughout the majority of the year (Figure 12). Because of this, the wetland community associated with this area will be slightly different from the seasonally inundated wetlands that have a more fluctuating hydrologic regime. Overall, this is a positive outcome and adds more diversity to the type of wetland habitat restored with the project.

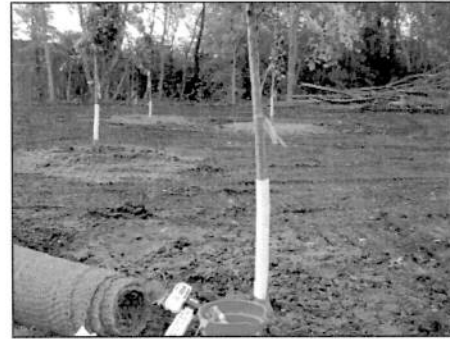
Figure 19. Installed Tree

A majority of the trees were installed with the assistance of a machine powered 3 ft auger. Holes were drilled to a depth approximately 0.5-1.0ft greater than root ball depth. Width of the hole drilled was expanded to at least 2X root ball width. Prior to drilling the hole the topsoil was preserved to one side of the hole to allow for use as backfill around the rootball. The hole was backfilled to the appropriate depth such that the top of the rootball was either flush or slightly lower than the surrounding finish grade. Excess material was used to create a water retention ring around the tree. Trees were watered to remove air spaces in the newly backfilled dirt (Figure 19).

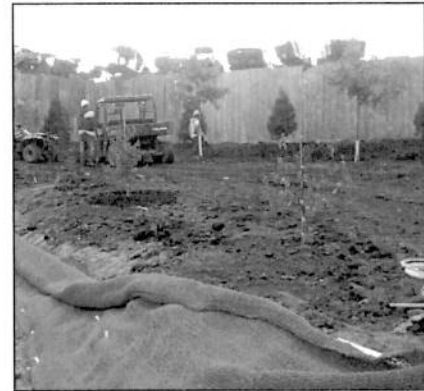
Figure 20. Installed Shrub

Shrubs were installed into hand dug holes. Topsoil was first preserved to one side of the hole. The hole was expanded to at least 2 times the container size and 0.25 to 0.5 ft greater in depth. Shrubs were carefully loosened from the pot and roots massaged from the root bound condition and placed into the hole flush or slightly below the surround finish grade. Shrubs were watered to remove air spaces in the newly backfilled dirt (Figure 20).

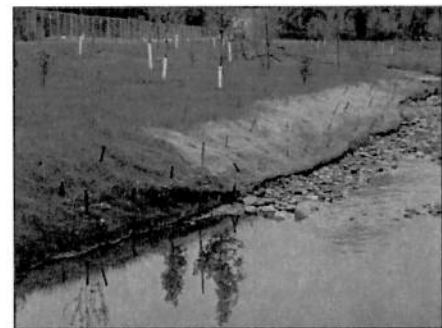
Figure 21. Live Stake Installed

Fast growing species such as willow and silky dogwood were focused along the stream banks in the form of live cuttings for bank stability and habitat (Figure 21). A total of 1,300 live cuttings were harvested (1,000) from northeast Ohio and purchased (300) from Ernst Seeds in Meadville PA. Live cuttings must be installed during the dormant season or early spring, therefore cuttings were installed in March and April. Cuttings were installed on approximately 3-5 ft centers along both banks of 1,200 ft of channel of the South and Middle zone completed in the Fall of 2009. A limited number of live stakes were installed in the North zone along the first meander bend downstream of Landon Street corner (~Station 11+00).

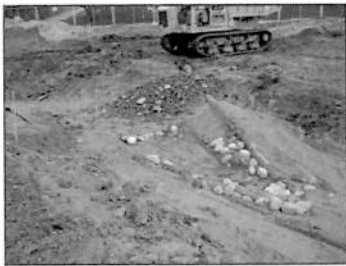
Figure 22. Log Vane

Woody material is an important component of headwater stream ecosystems and therefore woody debris was installed to form several different types of habitat that can be described as log-vanes, brush layering and log revetments (Figures 22-24). Thirteen woody habitat structures were installed throughout the project length. Specific woody debris locations, alignment, type and size was designed in the field at the discretion of the restoration biologist due to the variability of each location and source of wood. Installation of these structures generally occurred before finish grade. This approach allows logs to be buried into the bank, anchored with boulders and/or held into place with wooden "pins" that are essentially 3-5 inch diameter branches cut to a point. The length and diameter of the woody material comprising the habitat structure generally ranged from 10-20 feet in length and a diameter of 6-12 inches. All structures were installed at low angles, shallow slopes 2-5% and minimal protrusion heights to minimize risk with the structure relating to scour and flow affects. One structure at the beginning of the straight section in the North zone (just upstream of the Seiberling culvert) was a

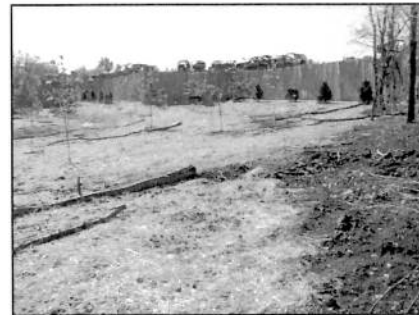
Figure 25. Deadfall Placement

Following topsoil placement, woody debris and logs were placed at locations in the floodplain and wetlands. The deadfall was generally placed at an angle with the flow of water. The deadfall provides additional habitat for wildlife and mimics the natural conditions of a wooded corridor and floodplain. Figure 25 provides an example of the amount and appearance of the deadfall prior to mature grass growth.
